**12<sup>th</sup>  
International  
Corrosion  
Congress**

September 19-24, 1993  
**VOLUME 2**  
Houston, Texas USA

# ***CORROSION CONTROL FOR LOW-COST RELIABILITY***

**PROCESS INDUSTRIES  
PLANT OPERATION**

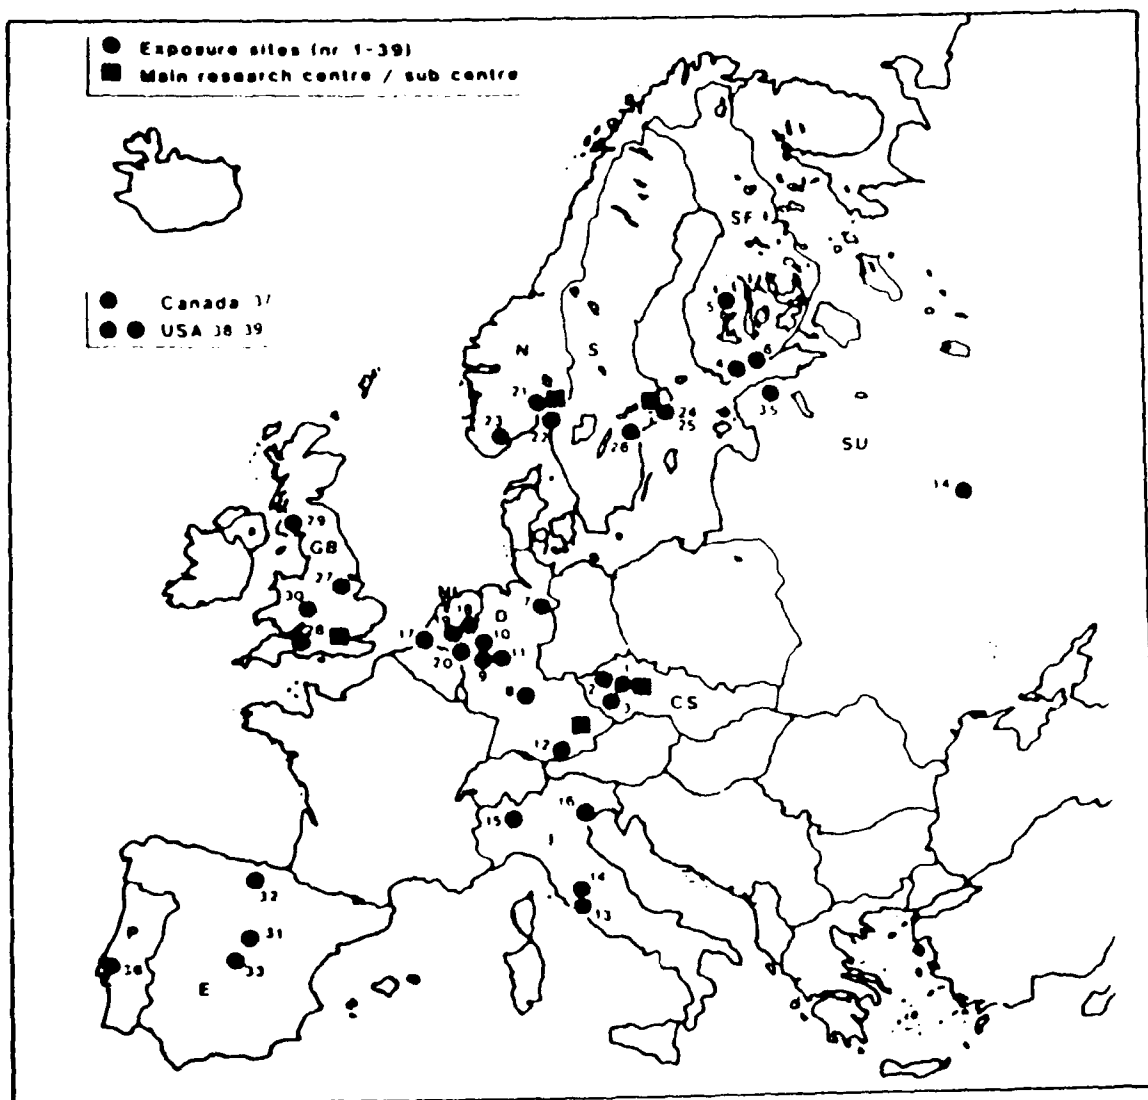
FIG 1. Network of test sites identified by the numbers found in Table 1

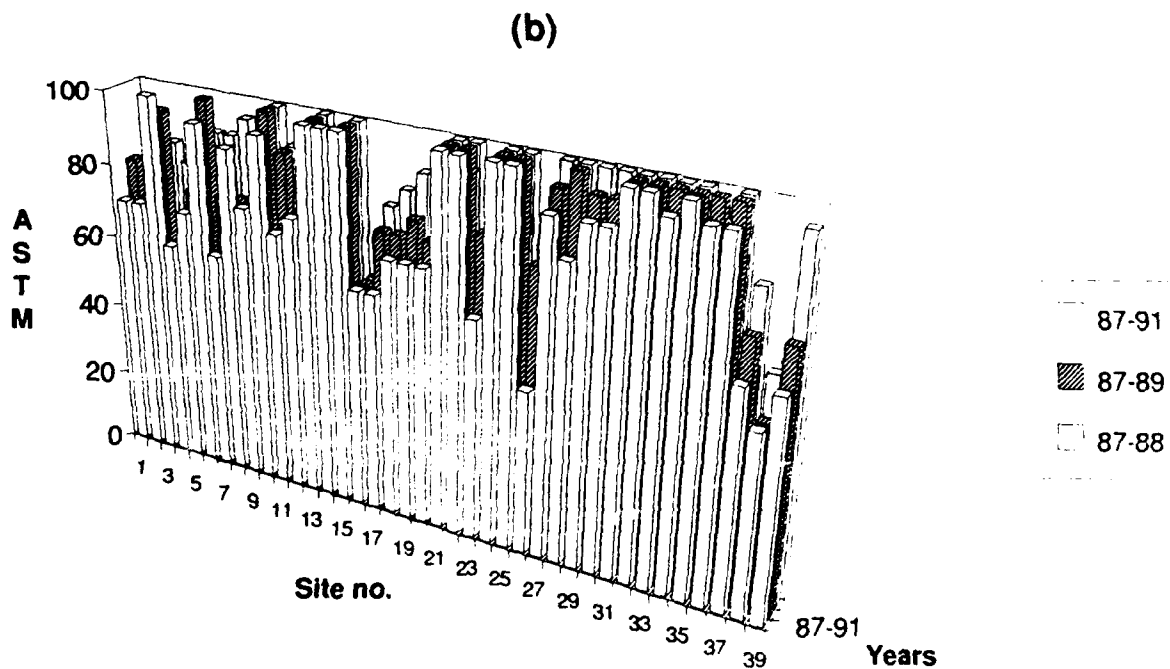
FIG 3. Steel specimens painted with a silicon alkyd paint:  
 (a) spread of defect from scratch after 4 year exposure, and  
 (b) occurrence of fungi after 1 to 4 year exposure

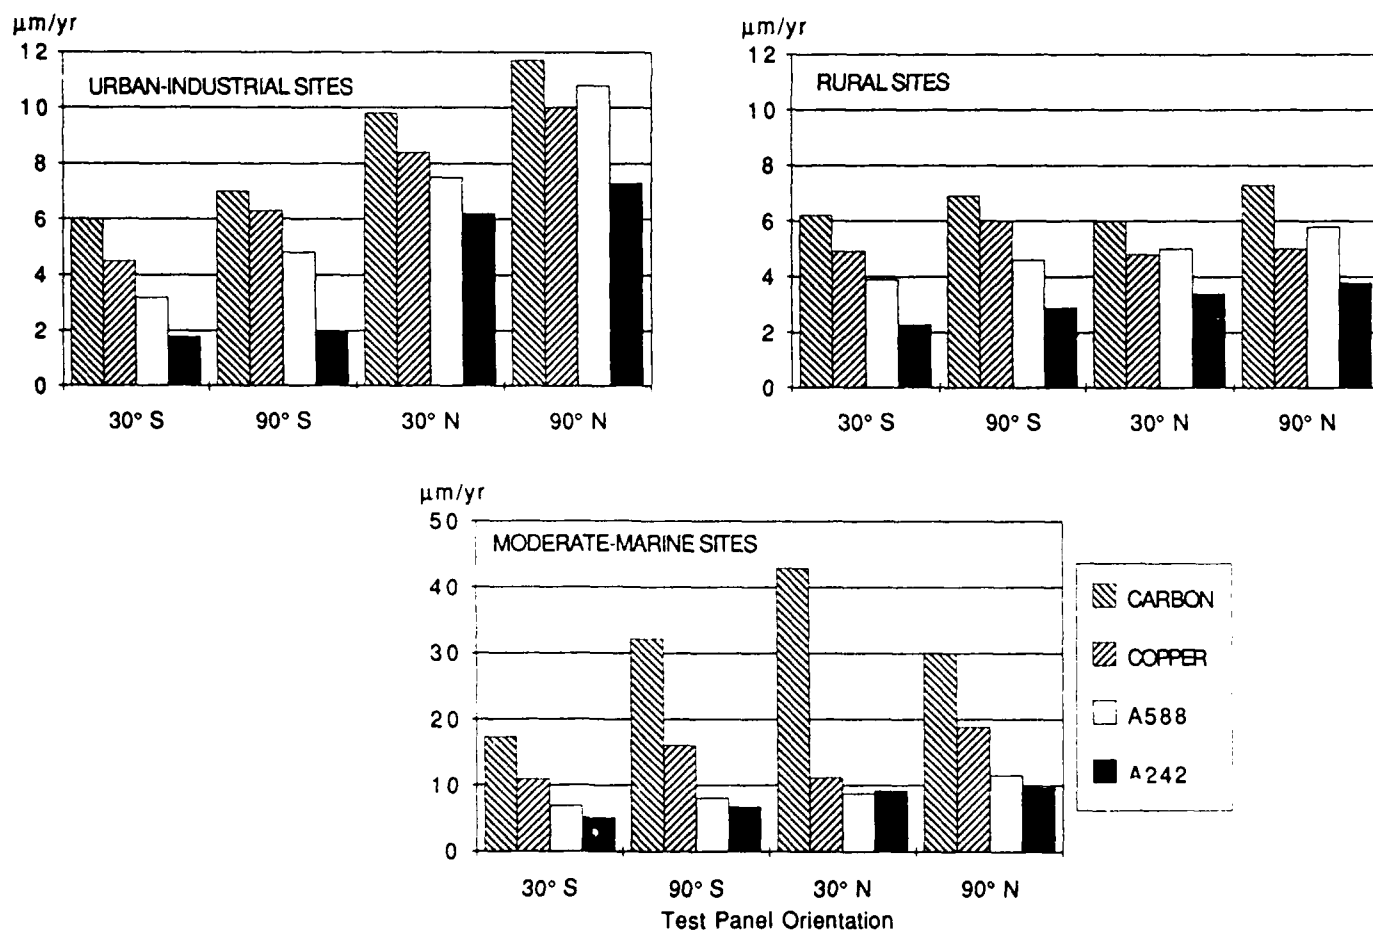
Figure 5. EFFECT OF TEST PANEL ORIENTATION ON AVERAGE 8-TO-16 YEAR CORROSION RATES

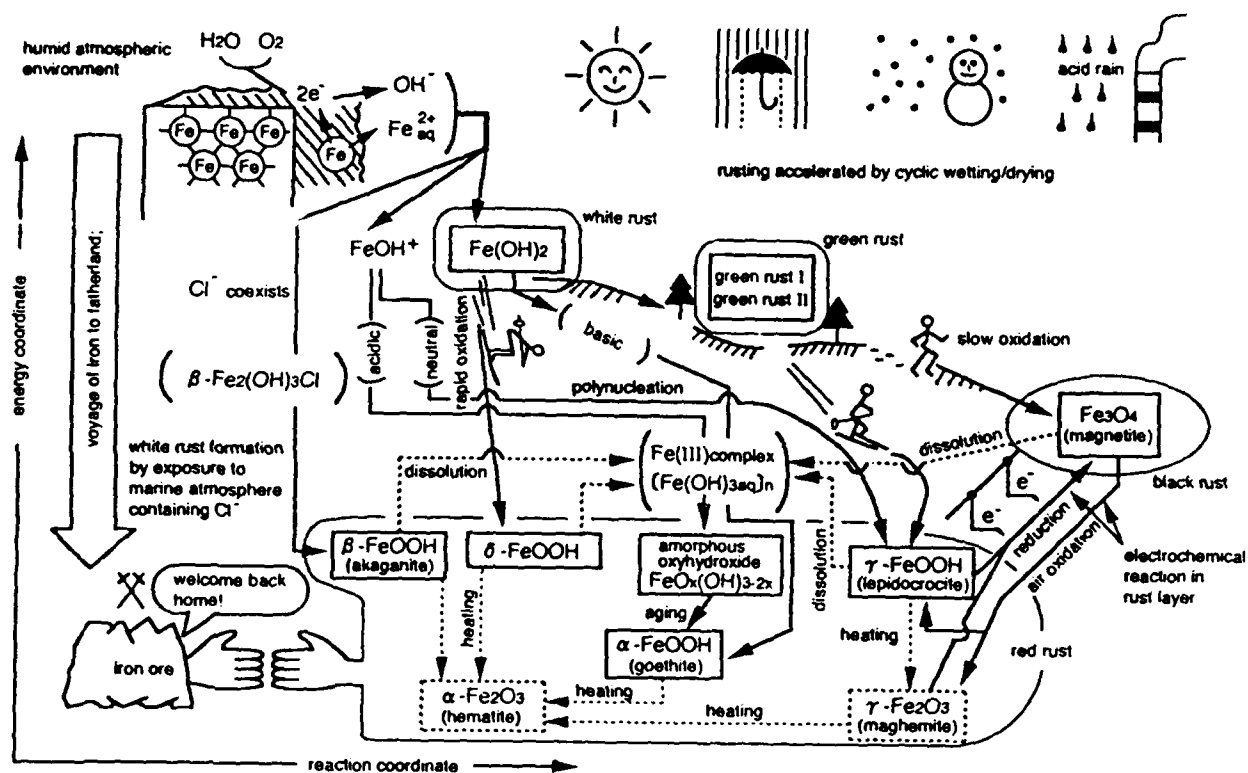
Fig. 1 Schematic processes of iron oxides and oxyhydroxides in atmospheric corrosion' (Misawa diagram).

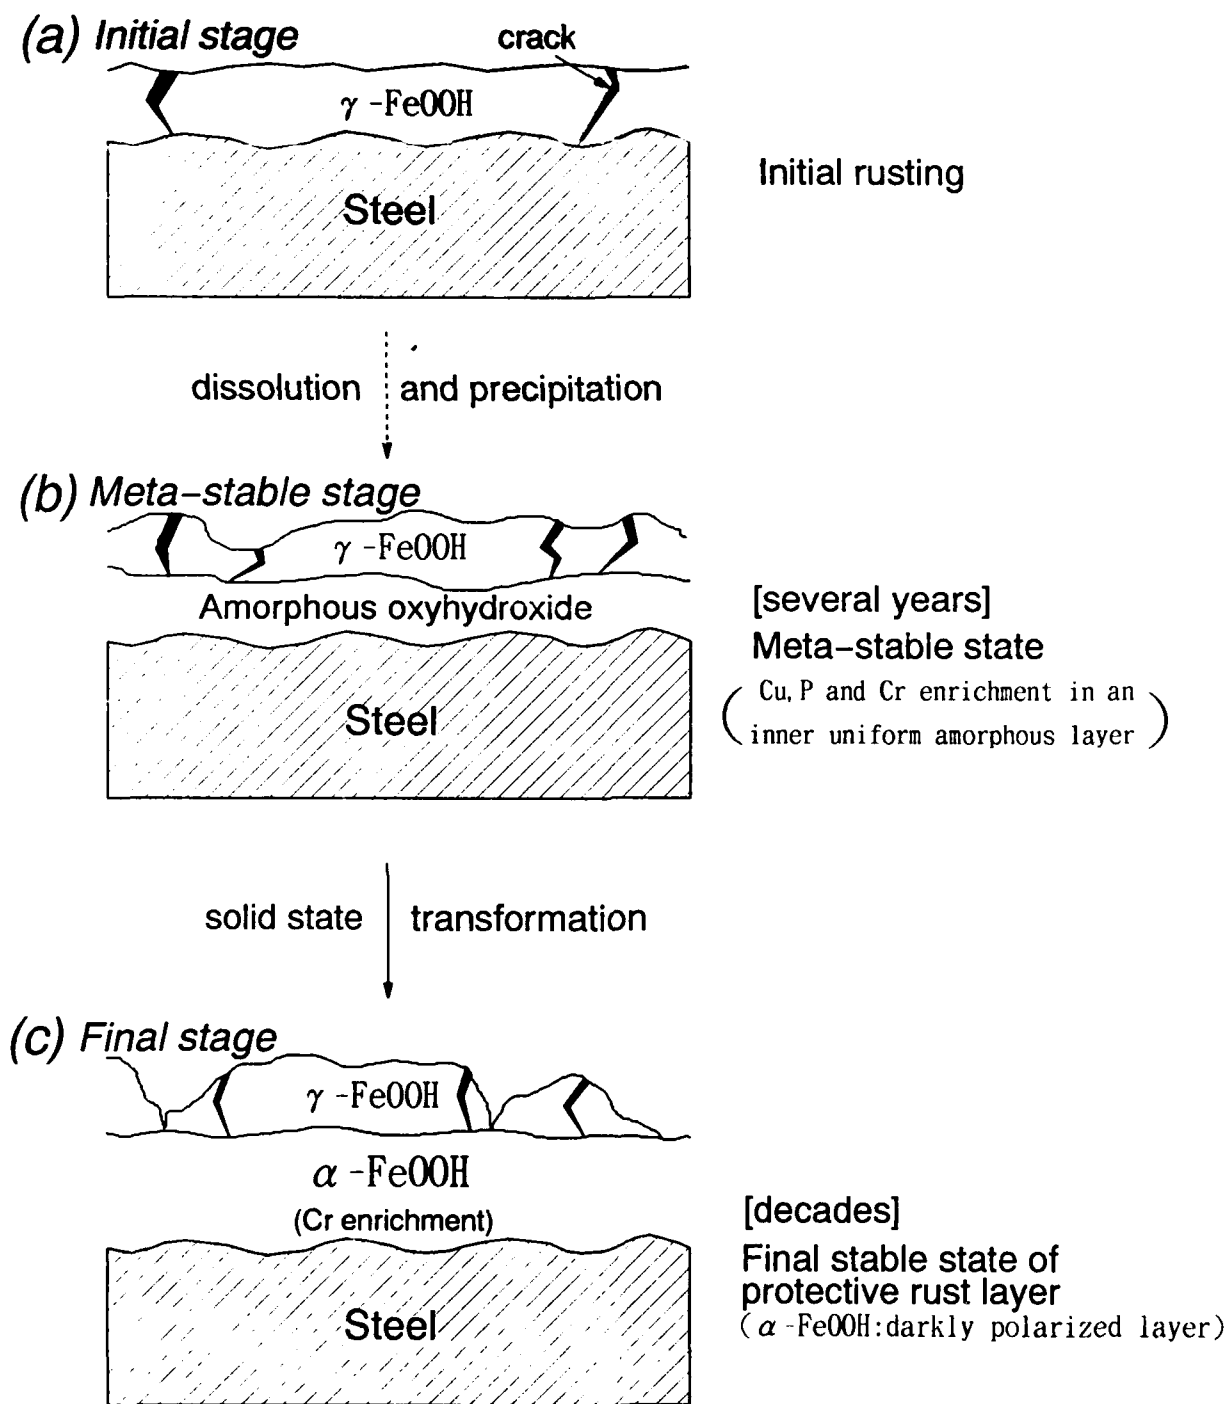
Fig. 4 Newly proposed schematic progress of alteration in stable and protective rust layer formed on a weathering steel in an industrial region.

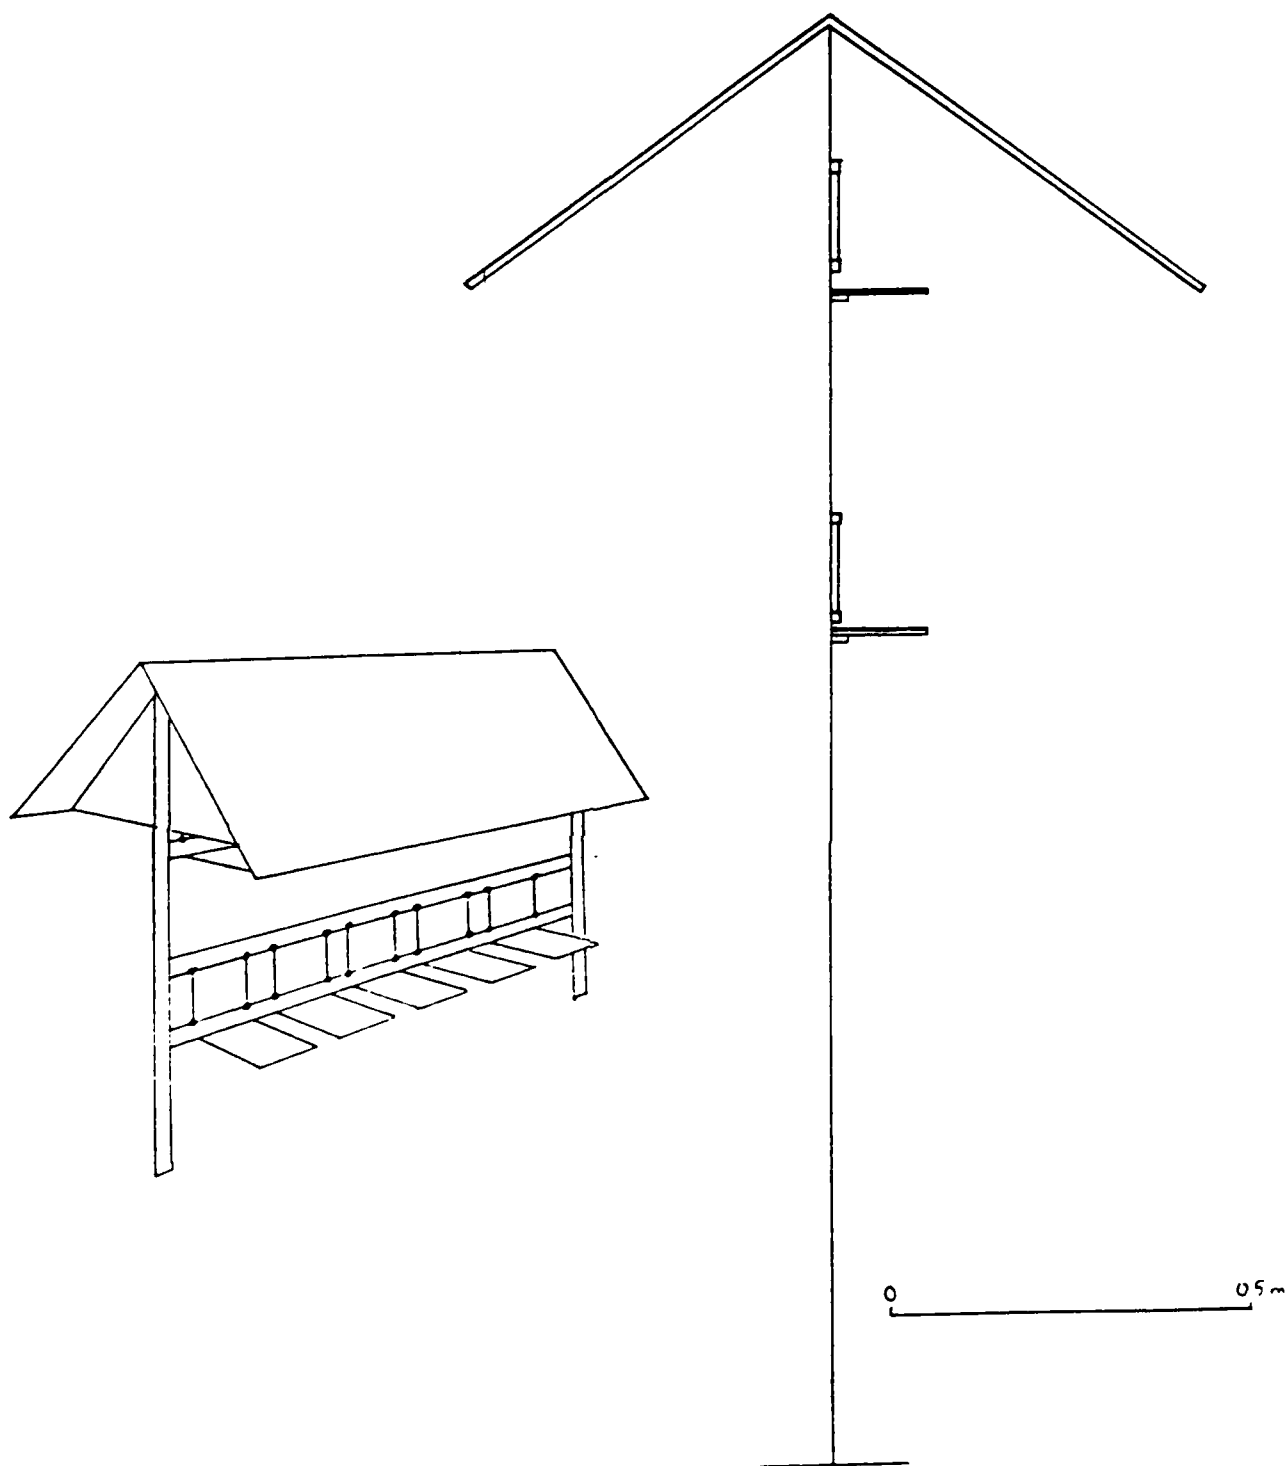
Figure 1. Exposure rack for partial and complete rain protection.

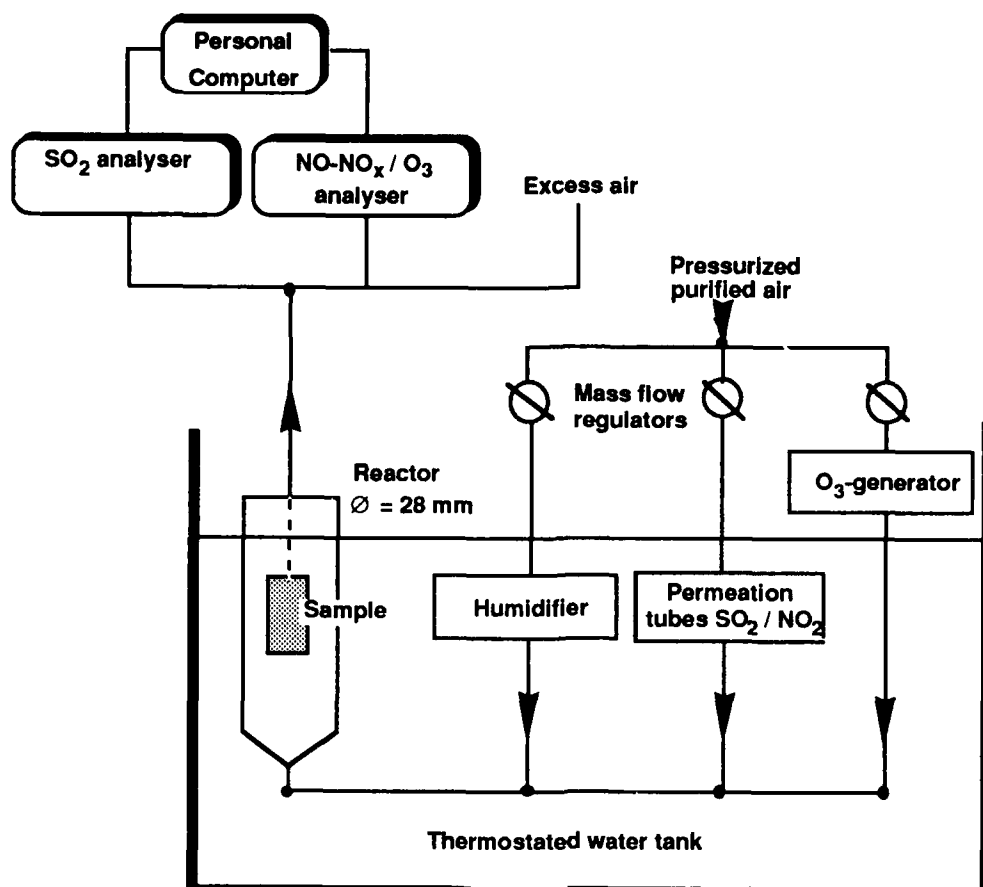
**Figure 1.** The experimental arrangement for time resolved trace gas analysis.

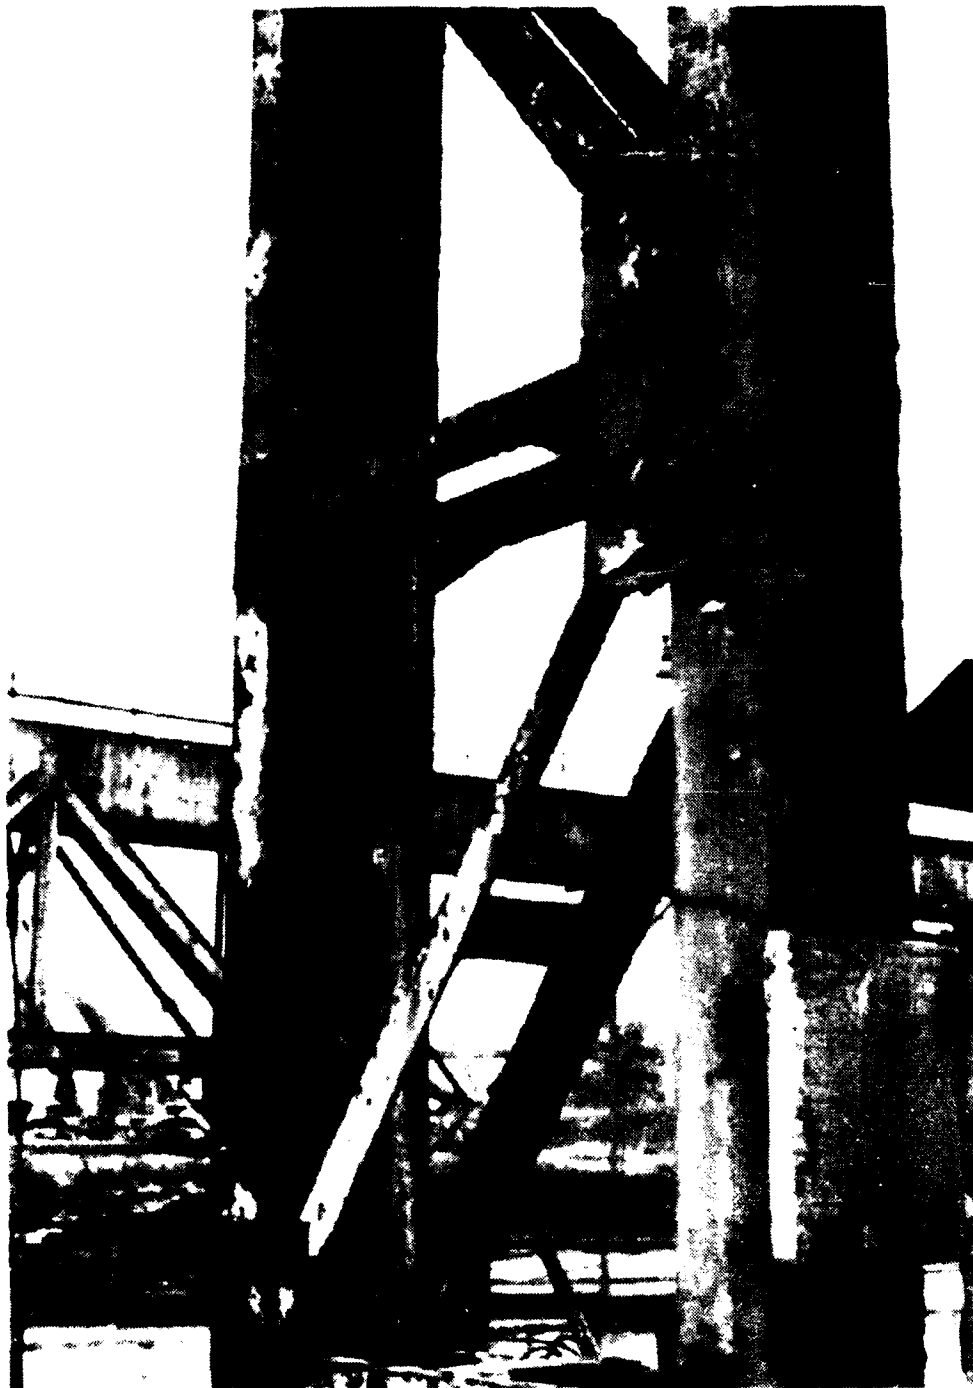
**Figure 3** Part of steel structure (technological crane track) applied in extreme conditions of metallurgical factory. Maintenance of protective systems was not rational, a new structure from weathering steel (with corrosion allowances of steel) was erected

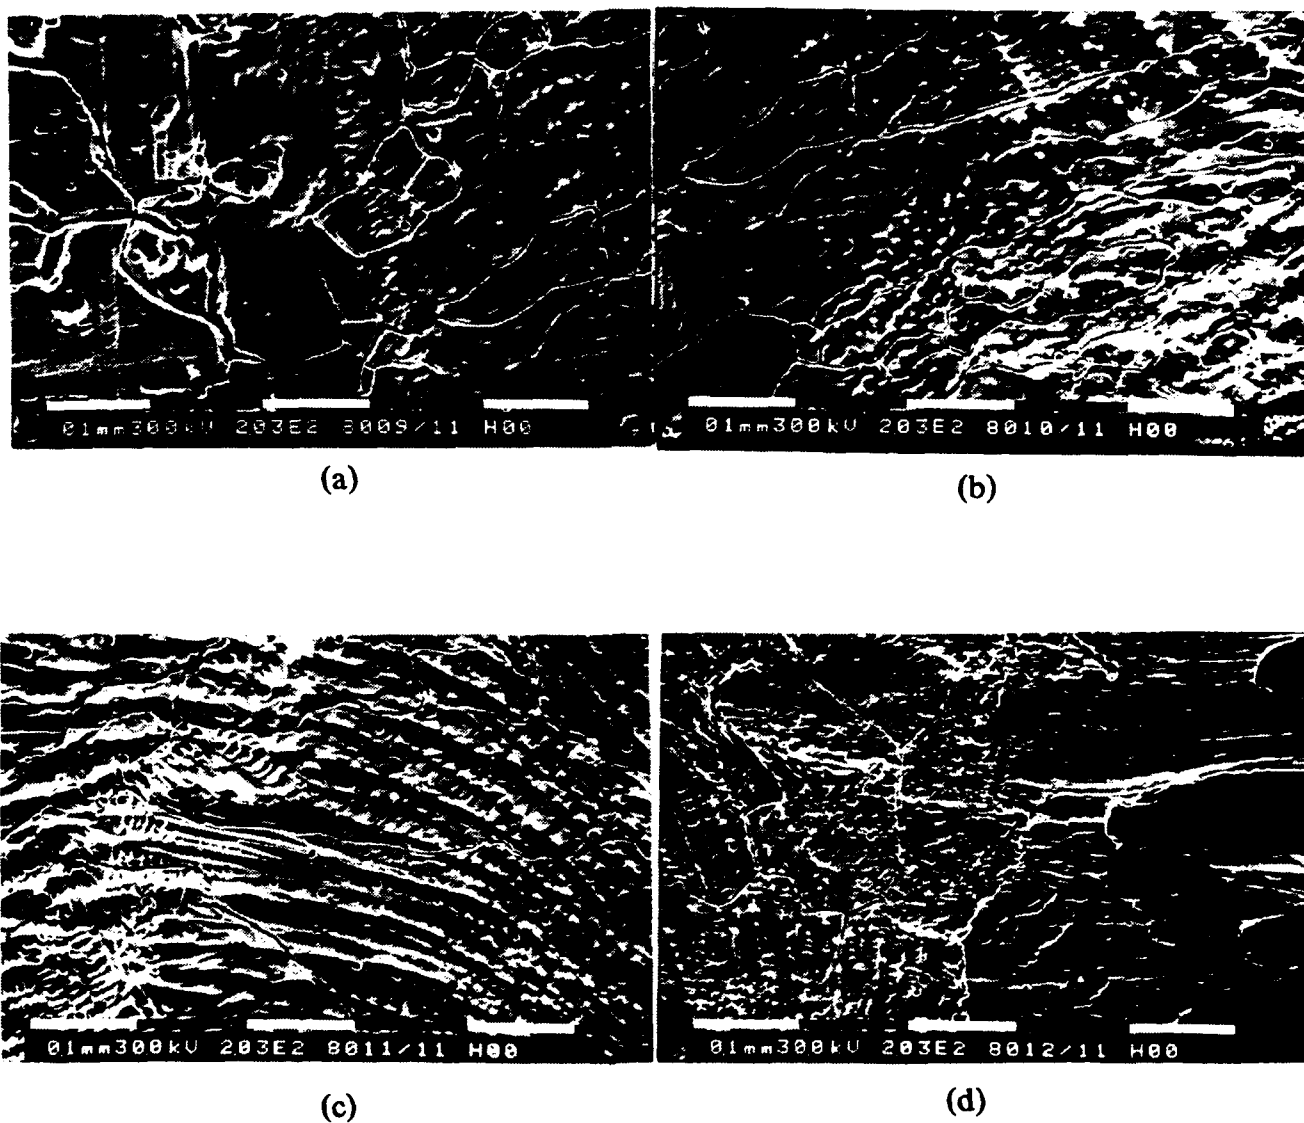
**Figure 2 Surface topography of welded junction 316L / 25-22-2LMn  
2-pass filling-wire / 2RE69 after corrosion test**

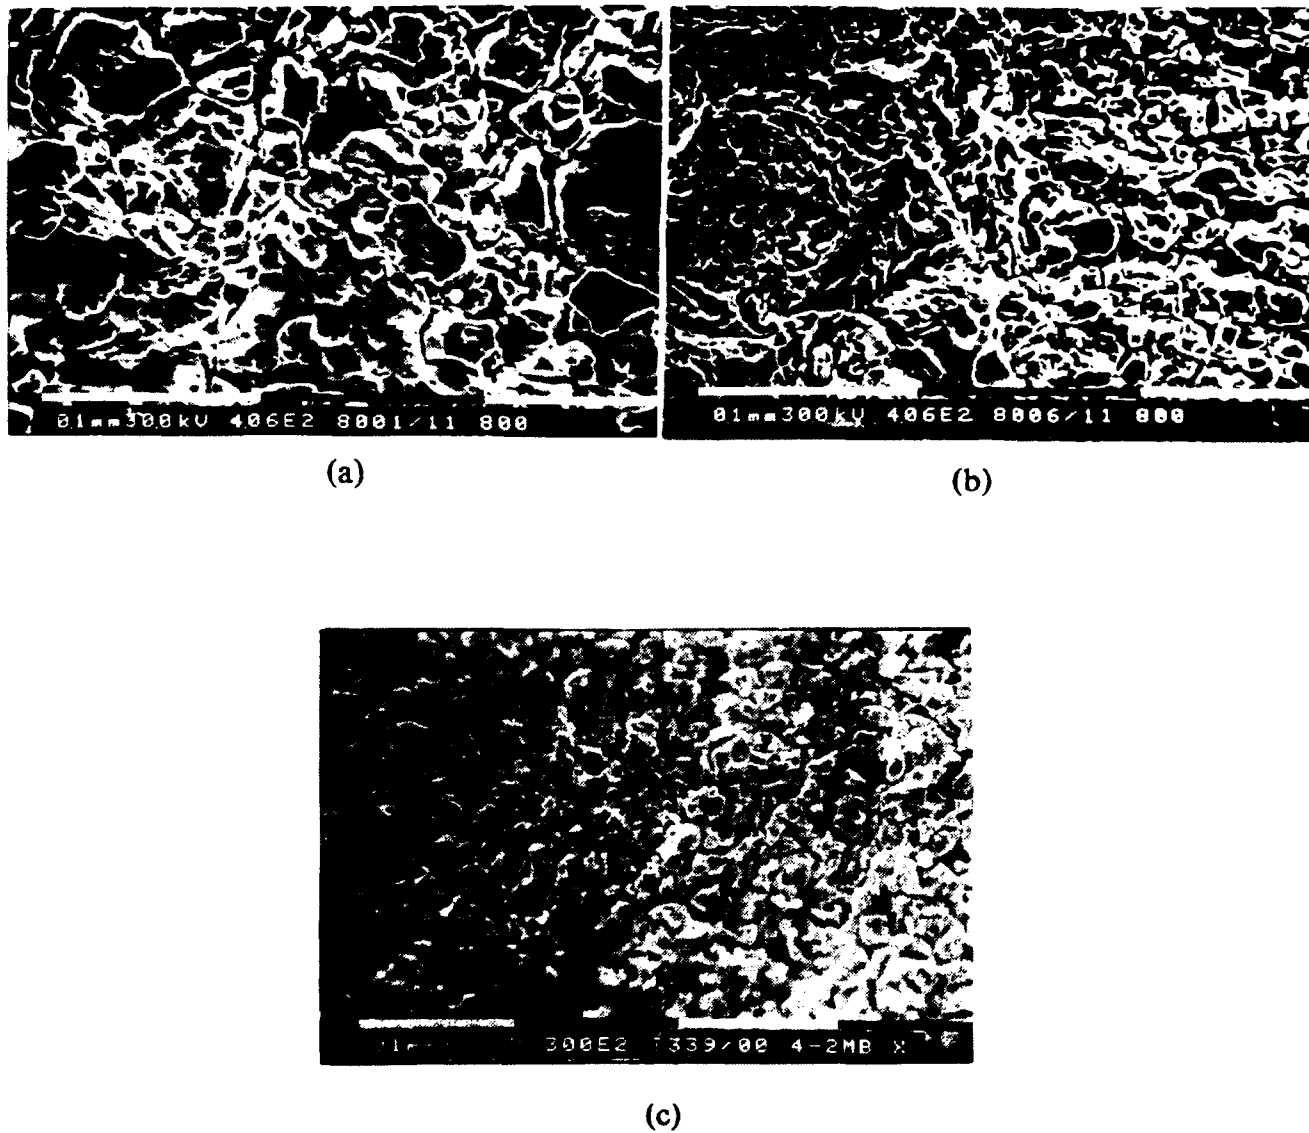
Figure 3 Surface topography of welded junction 316L / 25-22-2LMn

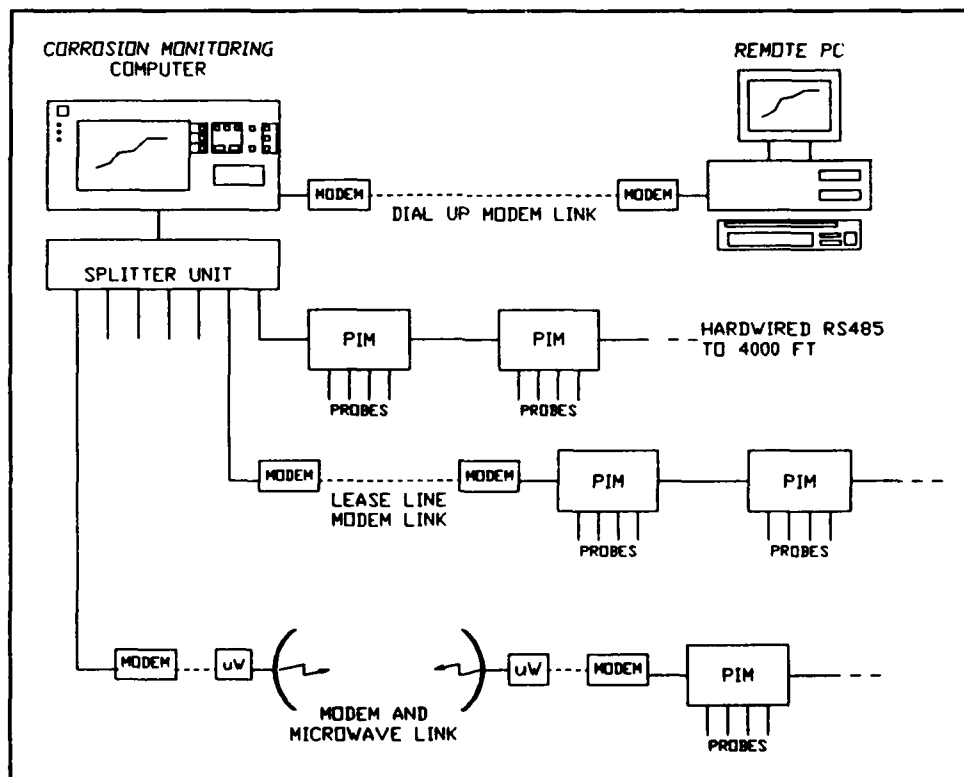
Figure 6 Continuous on-line real time corrosion monitoring

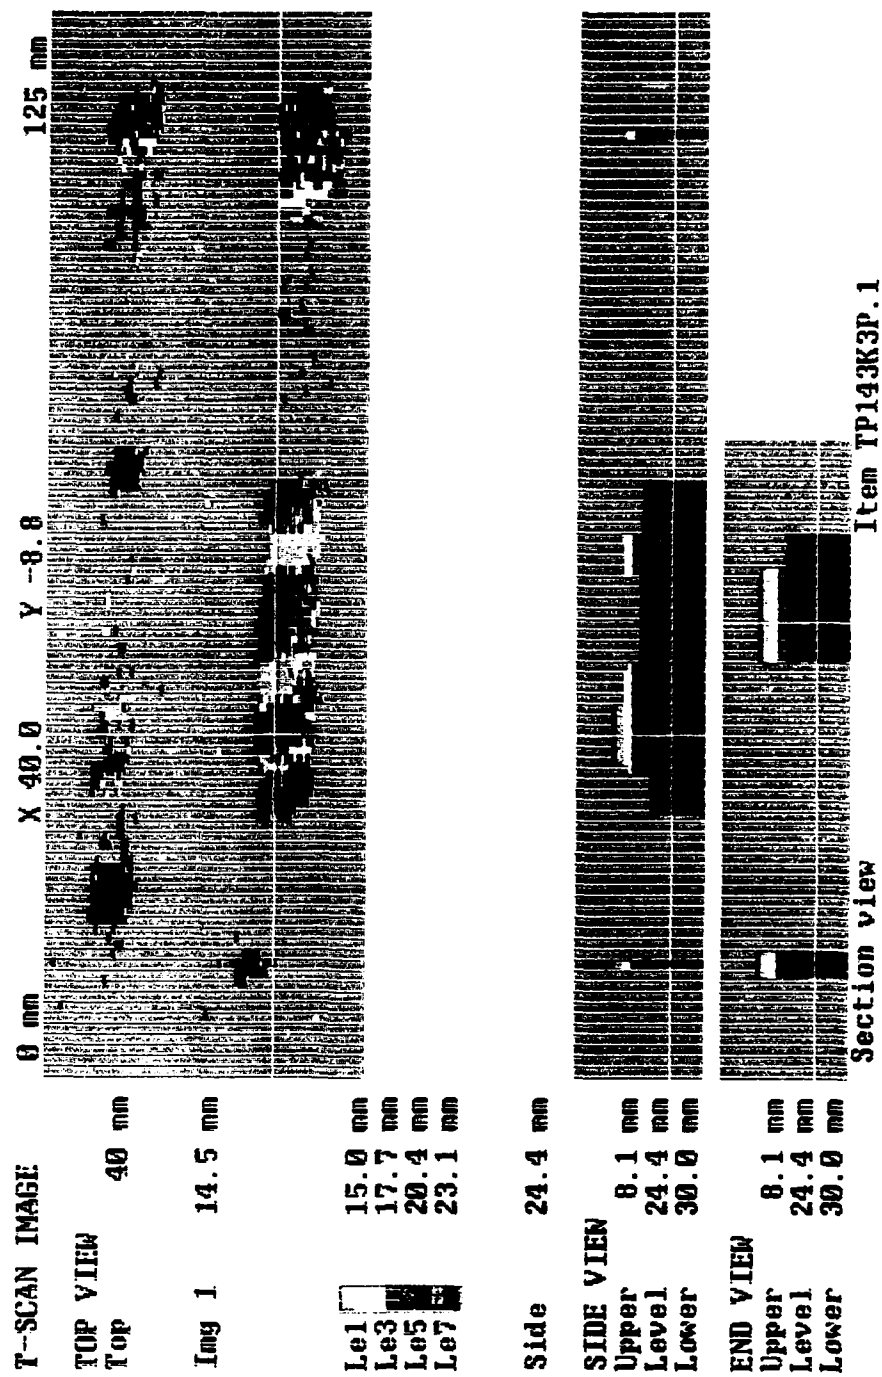
Figure 7. T-scan image of component subject to HIC.

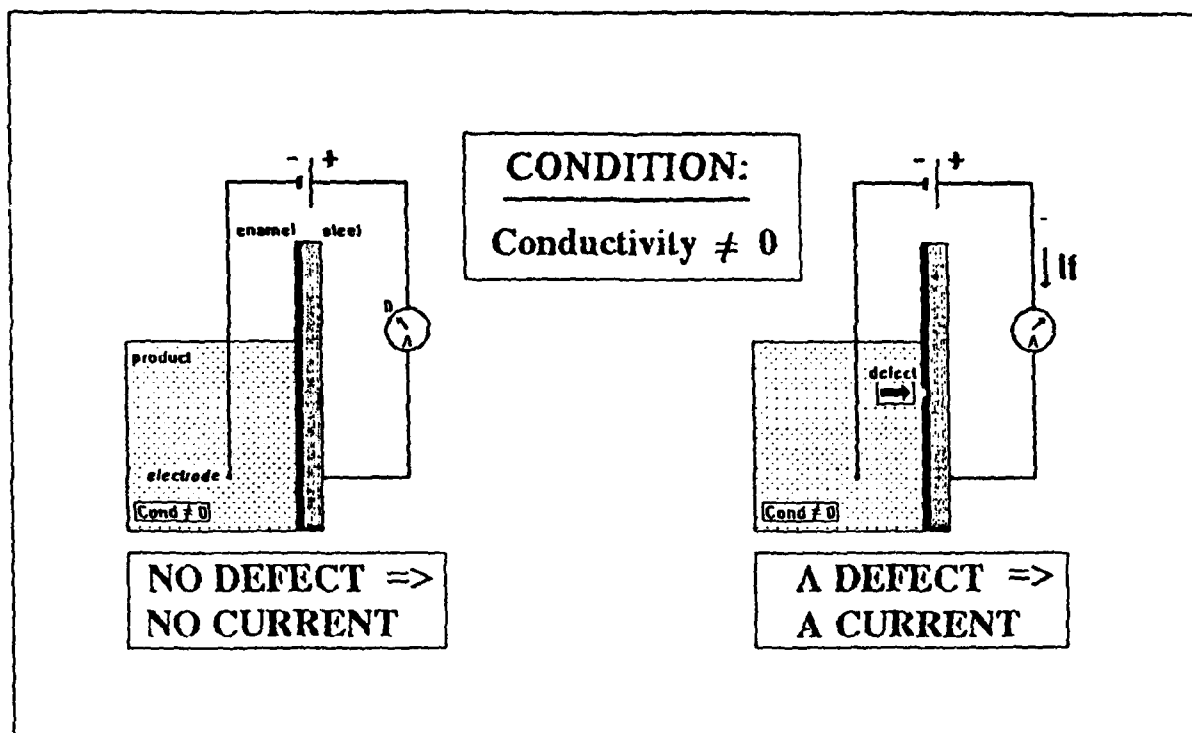
FIGURE 1: EMAILTEST WORKING PRINCIPLE

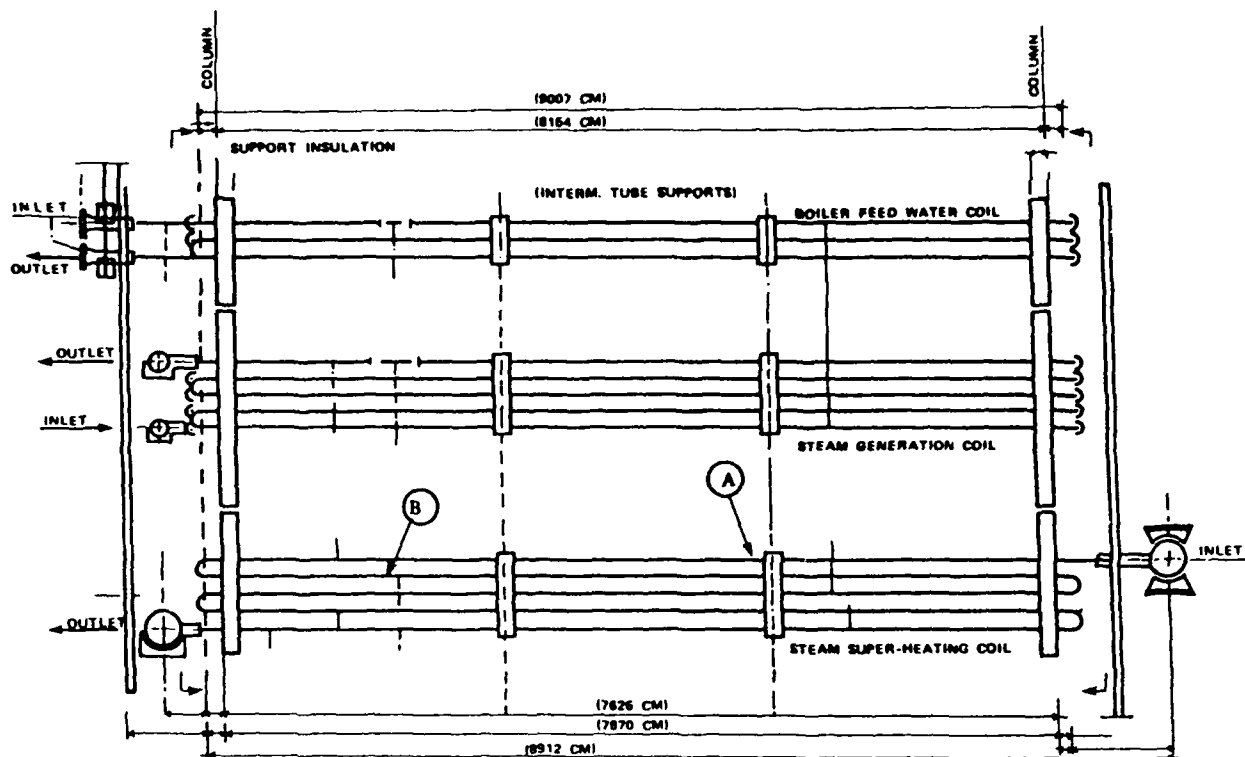
Figure 1. Schematic Arrangement of the Steam Super Heating (SSH) Coil in the Hydrocracker (HCR) Units showing Locations of Tube Failures in Units 1 and 2. (A and B respectively)

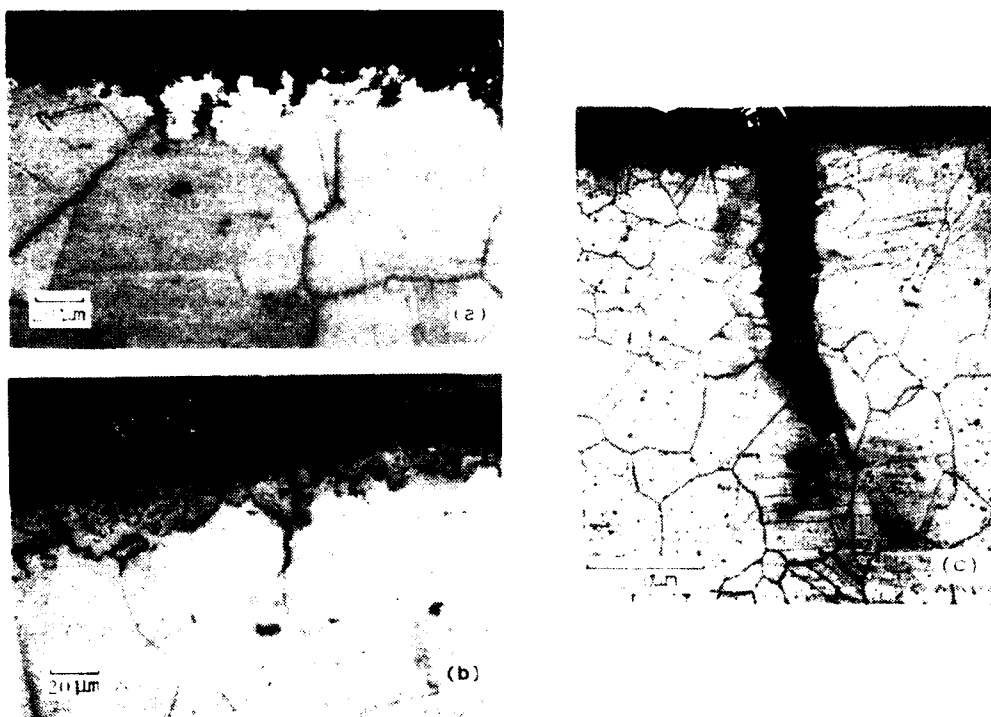
Figure 3. Micrographs of Cross-sections from the Tube of Unit 1 Showing : (a) Oxidation of the Flue Gas Side With Inter and Transgranular Penetration; (b) Intergranular Oxidation on the Steam Side; and (c) Transgranular Crack Originating From the Gas Side, Near the Base of the Welded Fin.

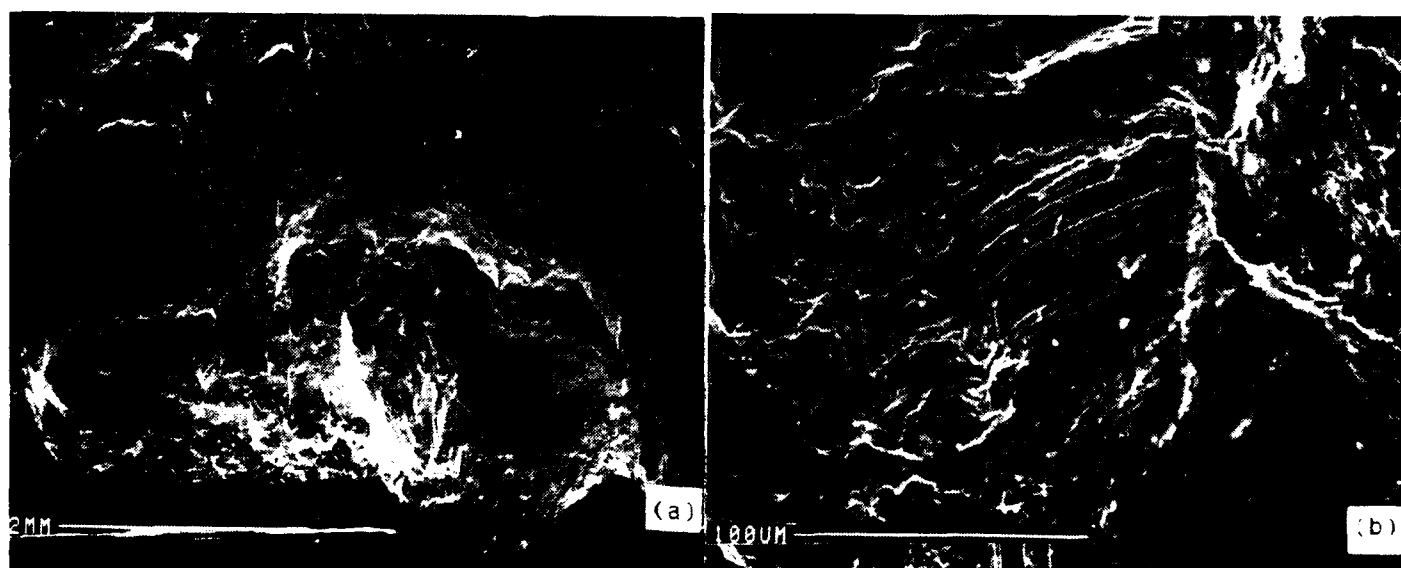
Figure 4. SEM micrographs Showing : (a) Low Magnification View of the Area Marked "X" on the Fracture Surface Shown in Figure 2; and (b) Fatigue Striations Observed in the Same Area in (a). Note - Direction of Striations is from the Steam Side to the Flue Gas Side of the Tube.

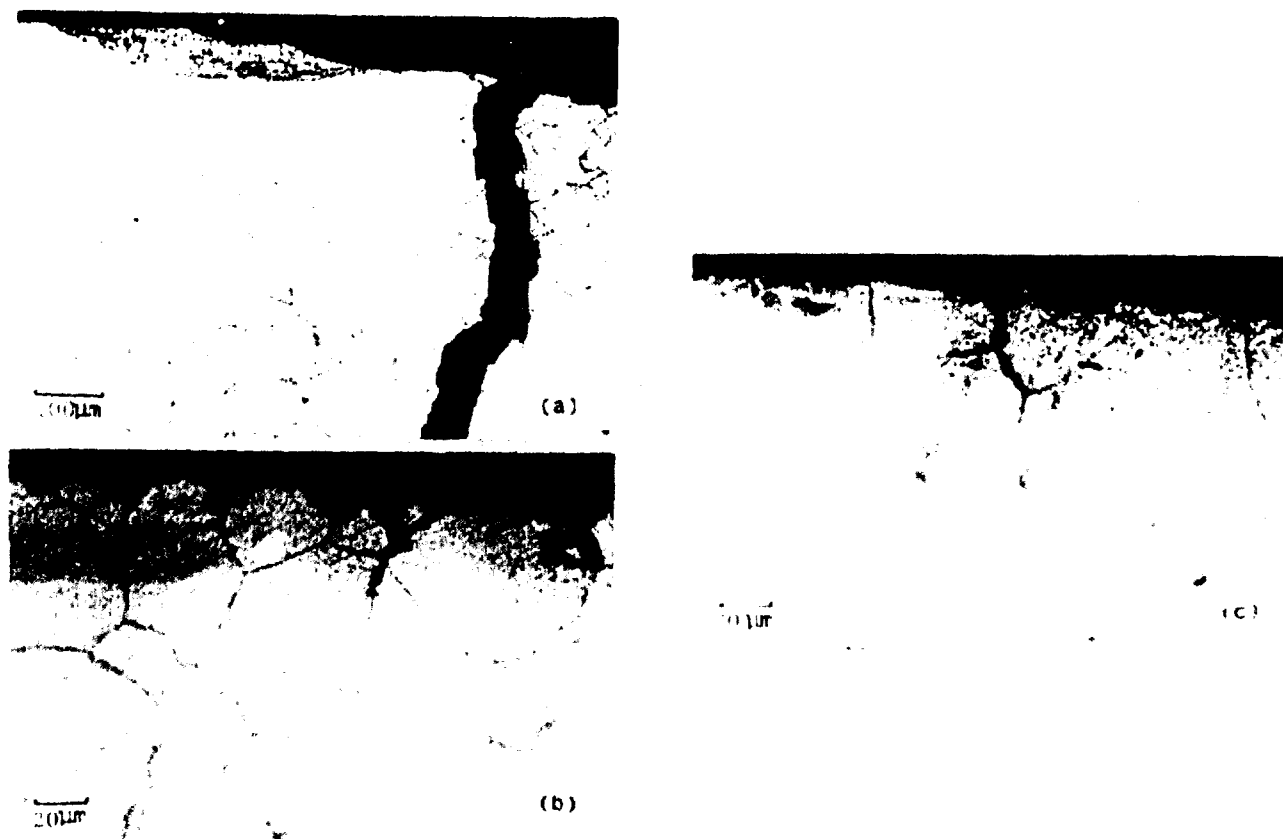
Figure 6. Micrographs Showing : (a) a Transgranular Crack Originating from Near the Base of a Weld; (b) Incipient Inter and Transgranular Fissuring on the Steam Side; and (c) Intergranular Fissuring on the Flue Gas Side of the Tube of Unit 2.
